Manhole Inspection Summary

Manhole # S47C__008MH

Insp Date: 7/11/08 11:35 AM

Location Address: **Montford**

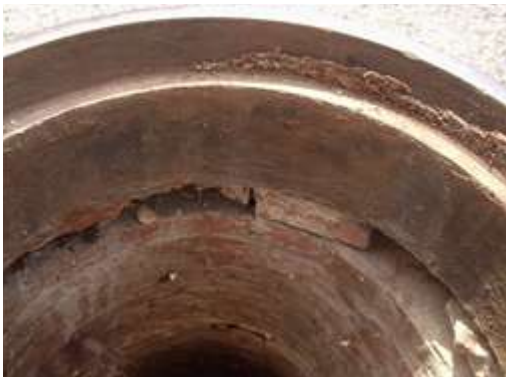
Defect 2

Condition: ☐ Sound ☐ Cracked ☐ Root Intrusion ☒ **Loose Brick** ☐ Deteriorated

Infiltration: ☐ None ☐ Joint ☐ Cracks ☒ **Mortar** ☐ Roots ☐ Wall

loose brick

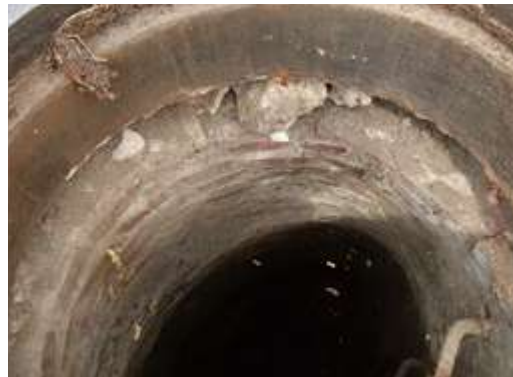
Defect 1

frame leaks

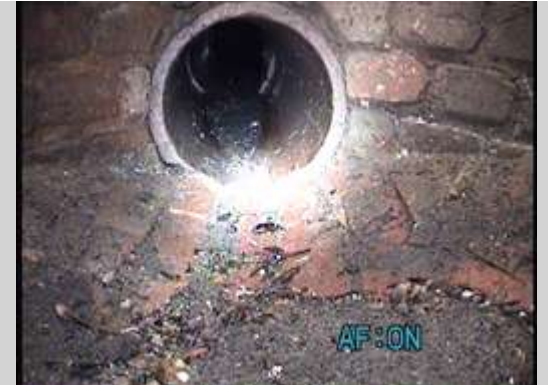
12 O'Clock Outflow

8 in. Circular Gravity Sewer
Pipe Out @ 12 O'Clock

Pipe Height: **8.4** (in.) Rod and Bar (Angled)

Pipe Material: **Clay** ☐ Pipe Lined

Invert Depth: **10.55** (ft.) Flow Characteristics: **None**

Infiltration: **None** Pipe Seal Cond: **Sound**
